## Summary Action Report

Structure ID: K-0009

Structure Name: Big Bay Culvert

Inspection Date: June 3, 2024

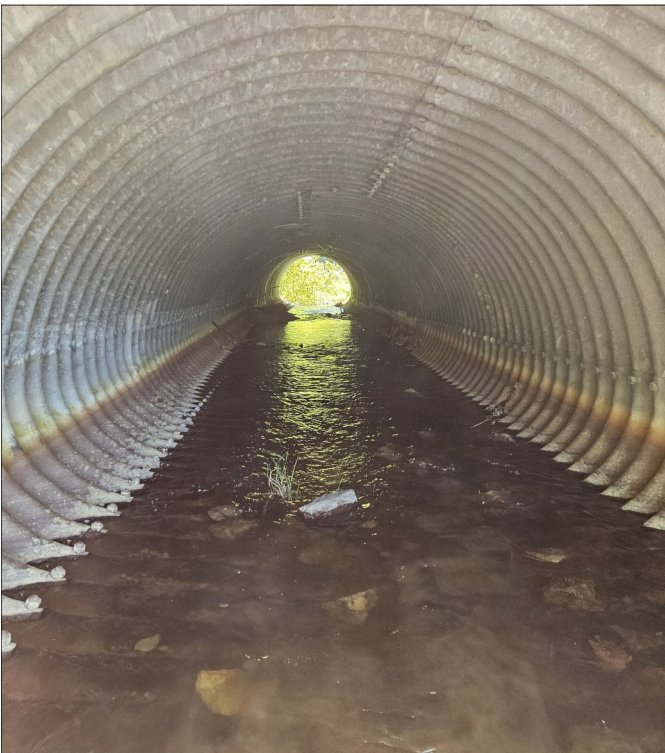
Photo 3 - View of Barrel Facing East.
