Summary Action Report

Structure ID: K-0009

Structure Name: Big Bay Sideroad Culvert

Inspection Date: June 3, 2024

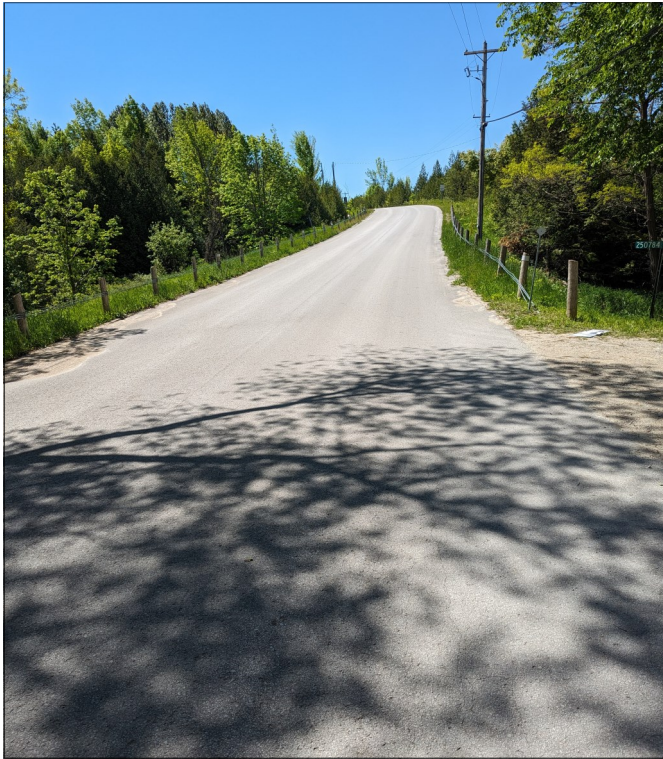
Photo 1 - View of Structure Facing South.

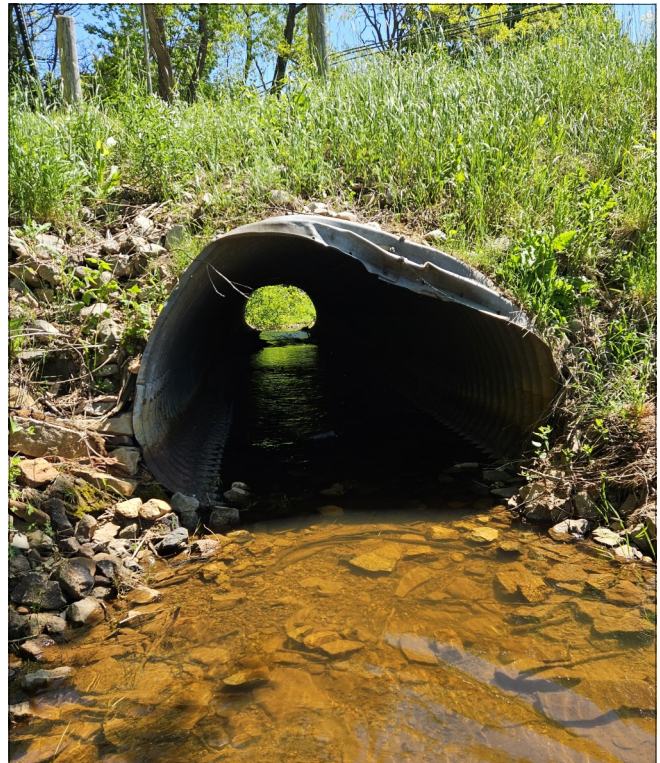
Photo 2 - View of West Culvert End.

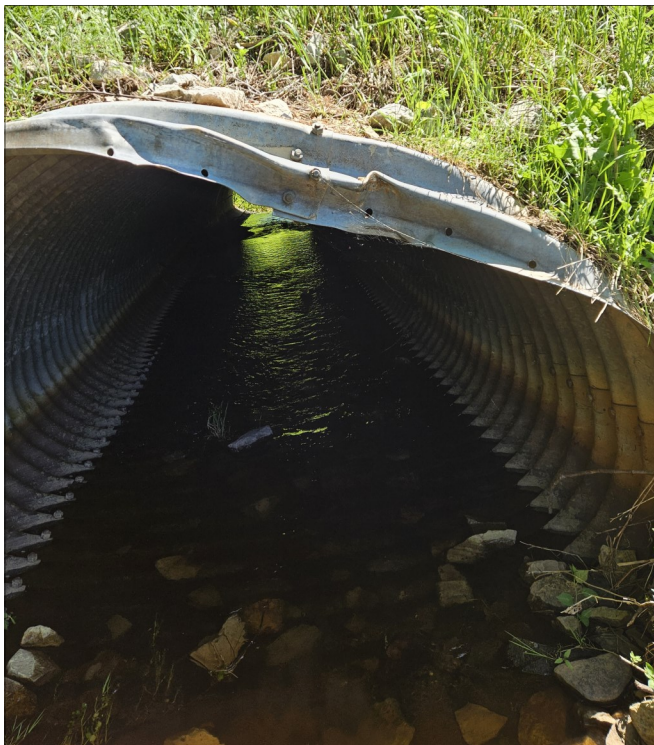
The structure appears to be in overall critical condition with large perforations and evidence of active overstressing of the culvert barrel walls. There are two large perforations noted at the north and south walls of the culvert. The north perforation measures 4.0m x 0.3m, which has caused the north wall of the barrel to settle and slip below the invert. Bolt hole cracking and crimping of the barrel corrugations was also noted along the south wall. Due to the presents of these deficiencies, the structure appears to be exhibiting buckling / failure issues and urgent replacement of the culvert (within 1 year) is recommended.

Photo 3 - View of Barrel Deformation.

\$5,000		
Investigation Notes: Monitoring of deformations recommended until structure is replaced. Recommend monitoring structure every 4 months.

Recommended Work: <input type="checkbox"/> Rehab <input checked="" type="checkbox"/> Replace				Maintenance Needs:		None
<input checked="" type="checkbox"/> Urgent <input type="checkbox"/> 1-5 years <input type="checkbox"/> 6-10 years <input type="checkbox"/> None				<input type="checkbox"/> Urgent <input type="checkbox"/> 1 year <input type="checkbox"/> 2 year		
Recommend the replacement of the structure within 1 year.

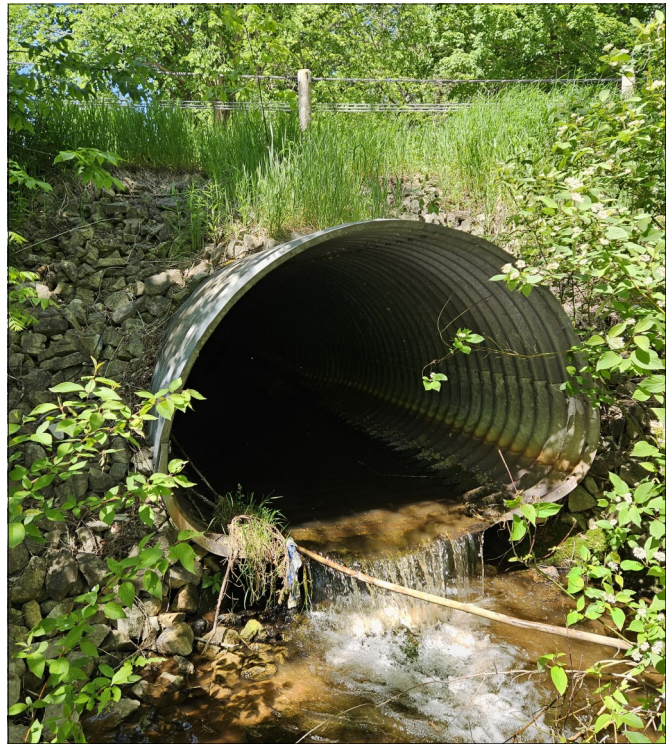
Photo 4 - View of East Barrel End

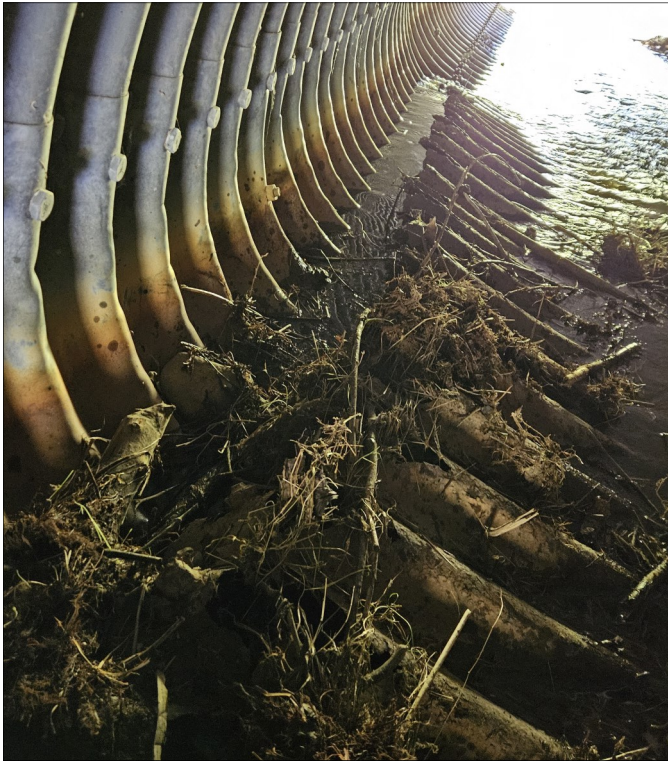
Photo 5 - View of Separation Within Culvert.

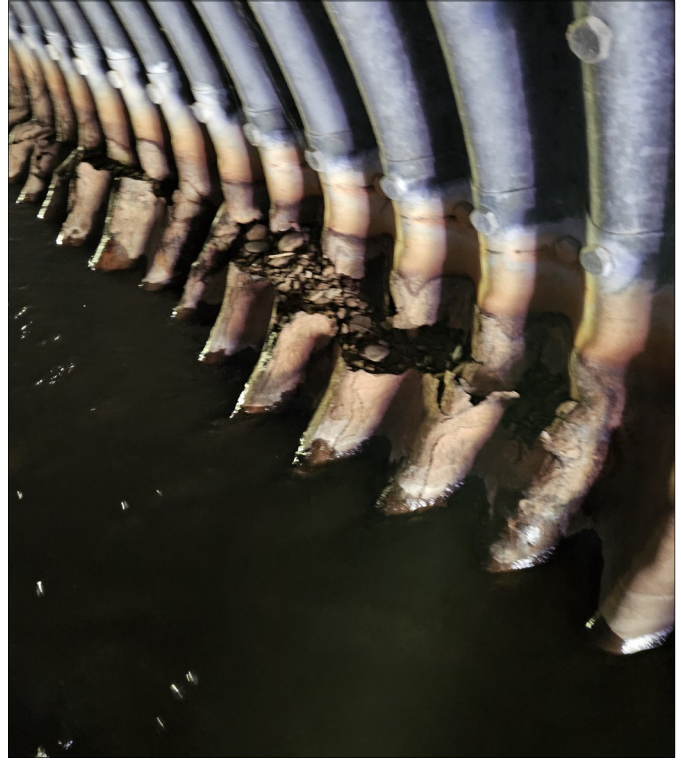
Photo 6 - View of Perforation Within Culvert.

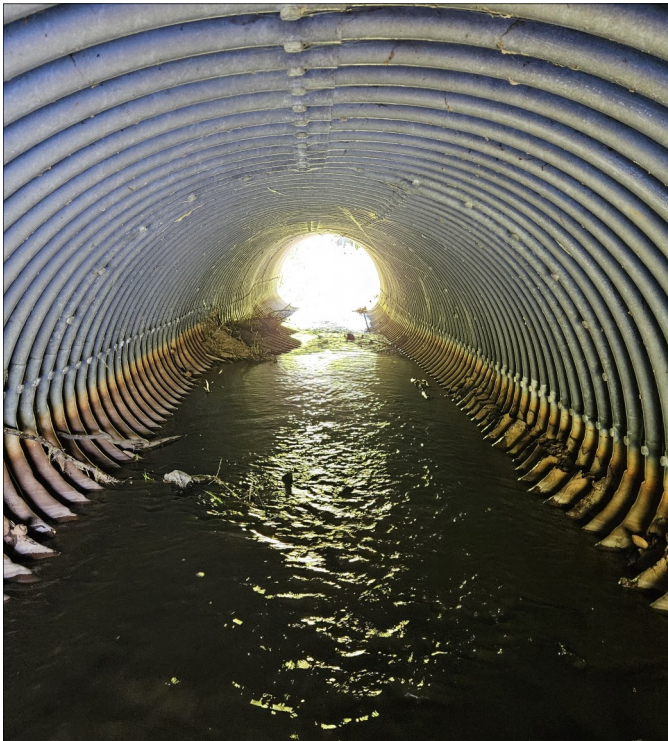
Photo 7 - View of Barrel

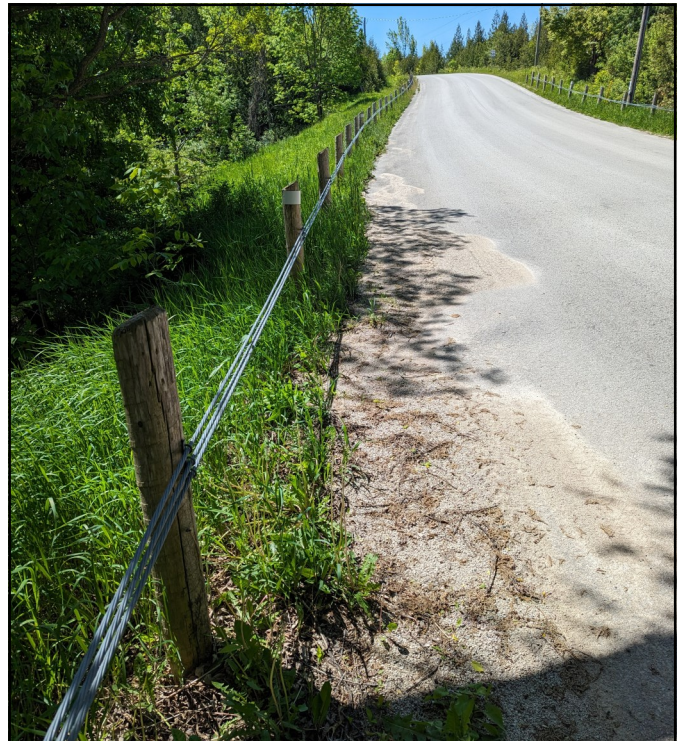
Photo 8 - View of Guardrail.

Guardrail system to be replaced during the culvert replacement.
