September 9, 2025  
Project No. 2505036

**Re: Engineering Support for Severance and Lot Development  
Karst Assessment for the property located at  
442538 Con Rd 21, Georgian Bluffs, ON, N0H 2T0**

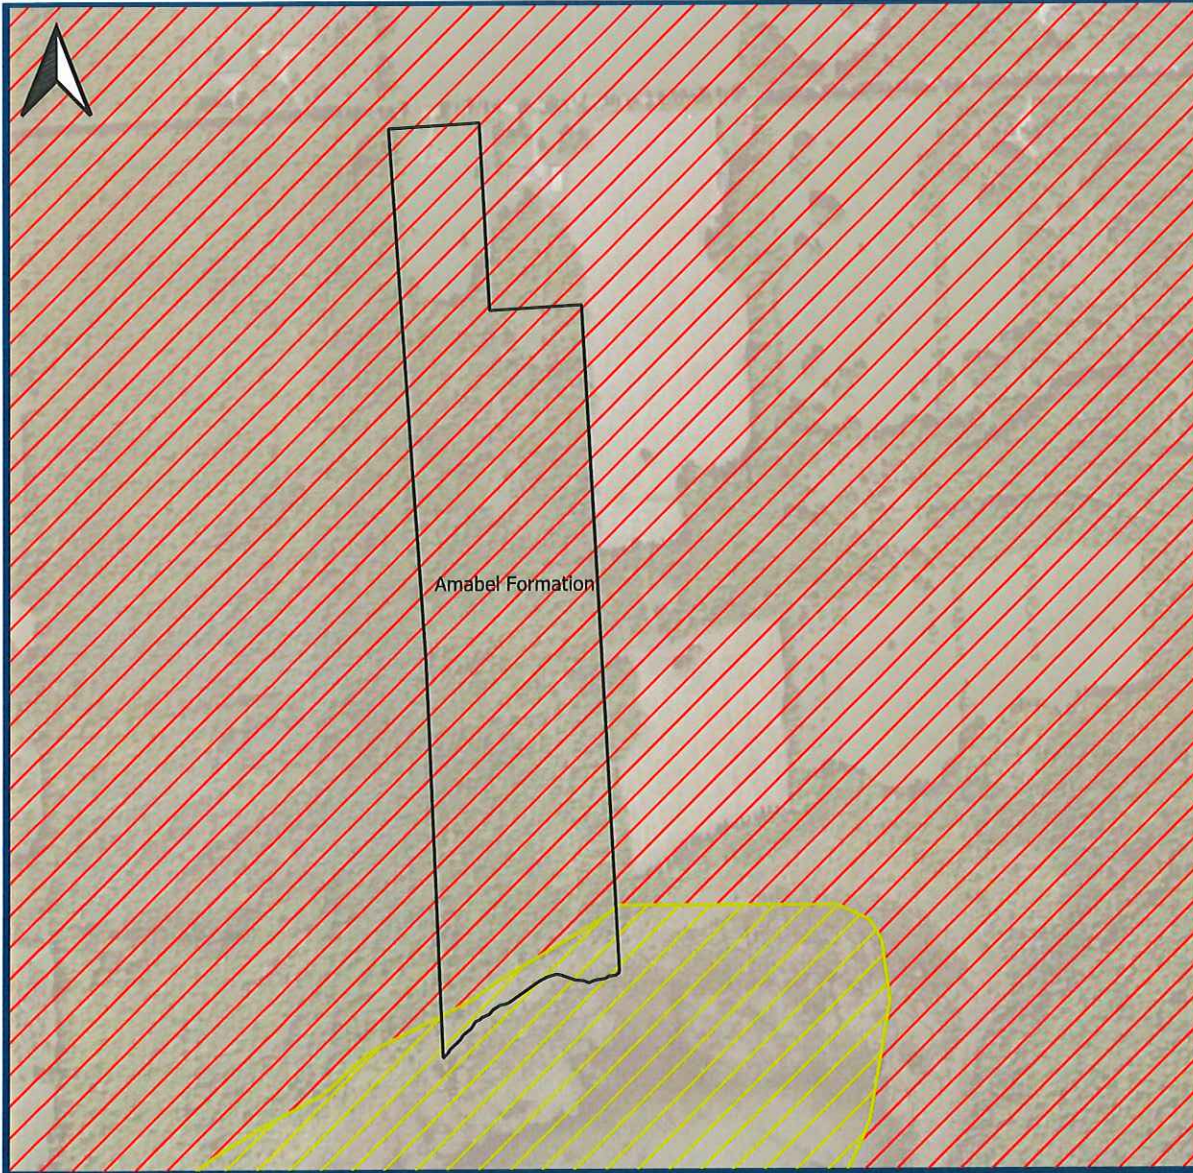
Figure 3

During the field activities, several instances of outcropping bedrock (at surface) were identified (indicated on Figure 3). Based on visual observations, they appeared to be weathered carbonate rock (dolostone) with a thin layer of vegetation growing over it. Based on the outcrop locations, it appears to be a E-W band of gently rolling bedrock topography.

5. The testholes were stopped when dolostone bedrock was encountered at depths varying from 0.51 mbgs to 0.99 mbgs. The bedrock was tan coloured when weathered with a grey colour on the fresh surface when broken. No hummocky features or fractures/fissures were evident.

1. That at the time of construction, if bedrock is encountered, that the bedrock surface be inspected in areas where it is exposed and in the locations of the proposed footings in order to confirm the nature of the bedrock and the presence or absence of any fractures or dissolution features that may pose structural limitations or potential for mass wasting under sewage systems.
2. The thickness of overburden be confirmed where sewage systems (if applicable) are constructed to ensure that the requirements of the Ontario Building Code are met. Should excavations encounter significant fractures or karst features, a qualified person should be retained for further inspection.

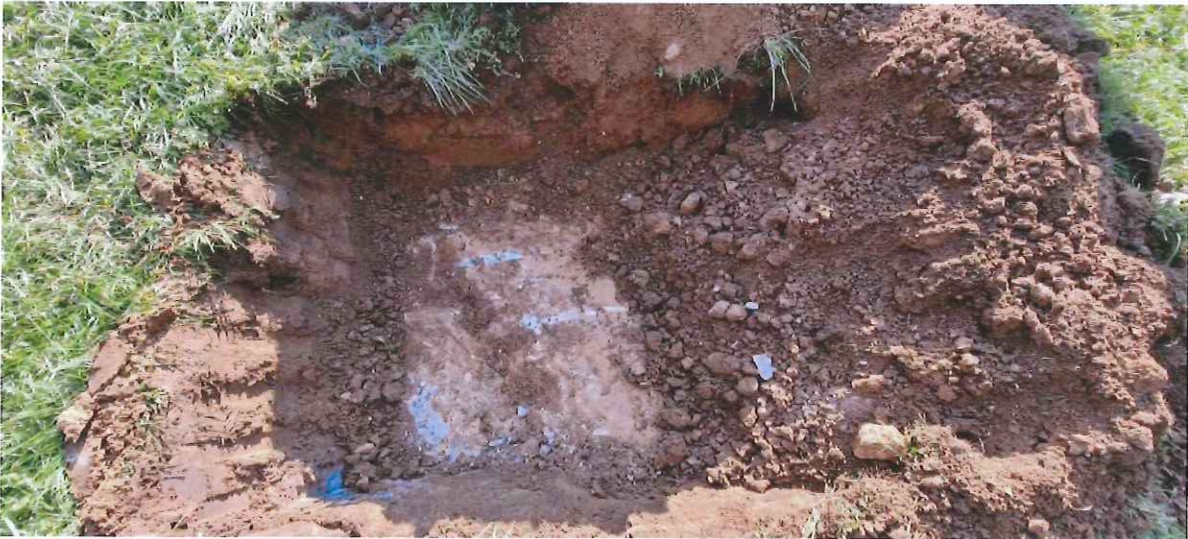
Picture 1: TH-01 - Overhead view.

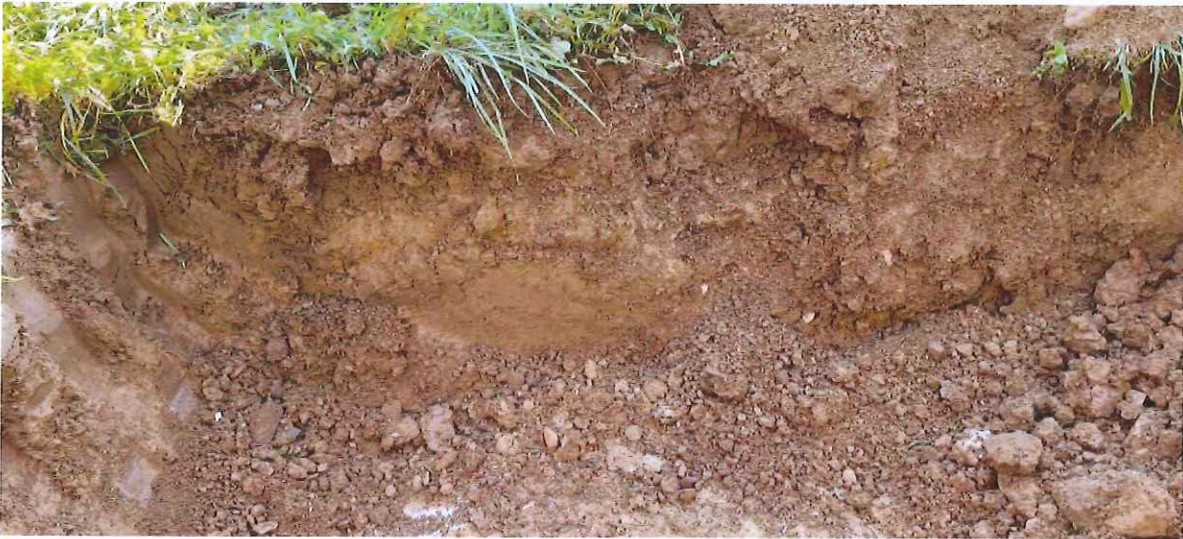
Picture 2: TH-01 - Side view showing soil profile.

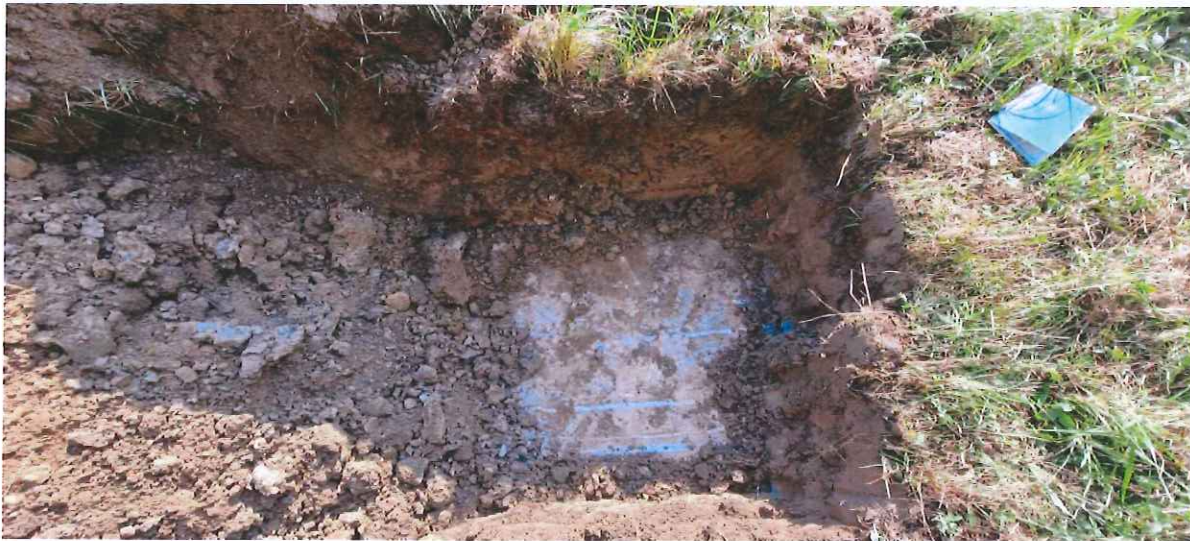
Picture 3: TH-02 - Overhead view.

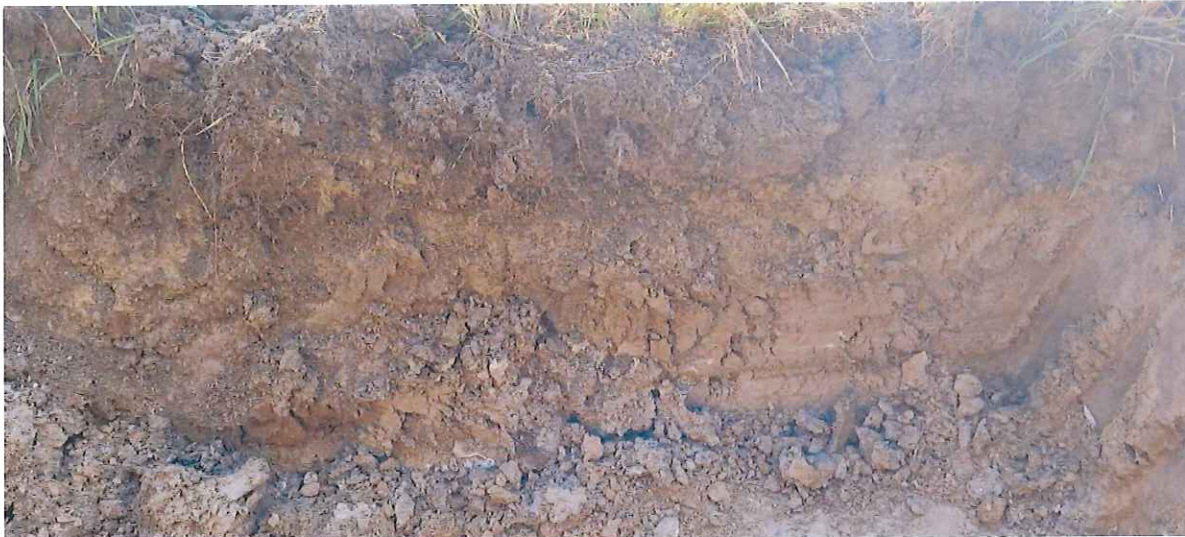
Picture 4: TH-02 - Side view showing soil profile.

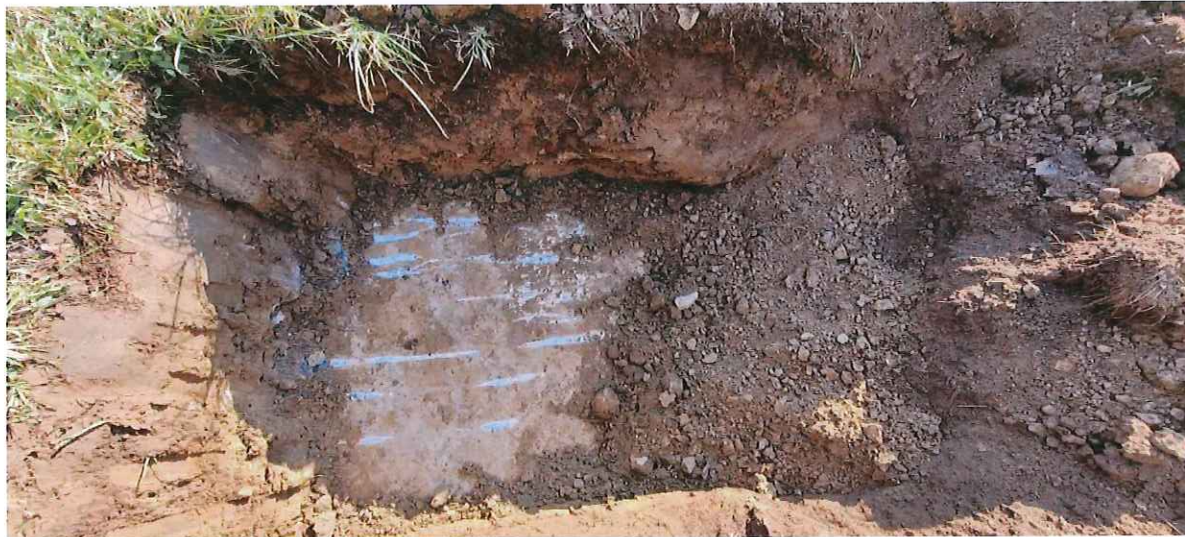
Picture 5: TH-03 - Overhead view.

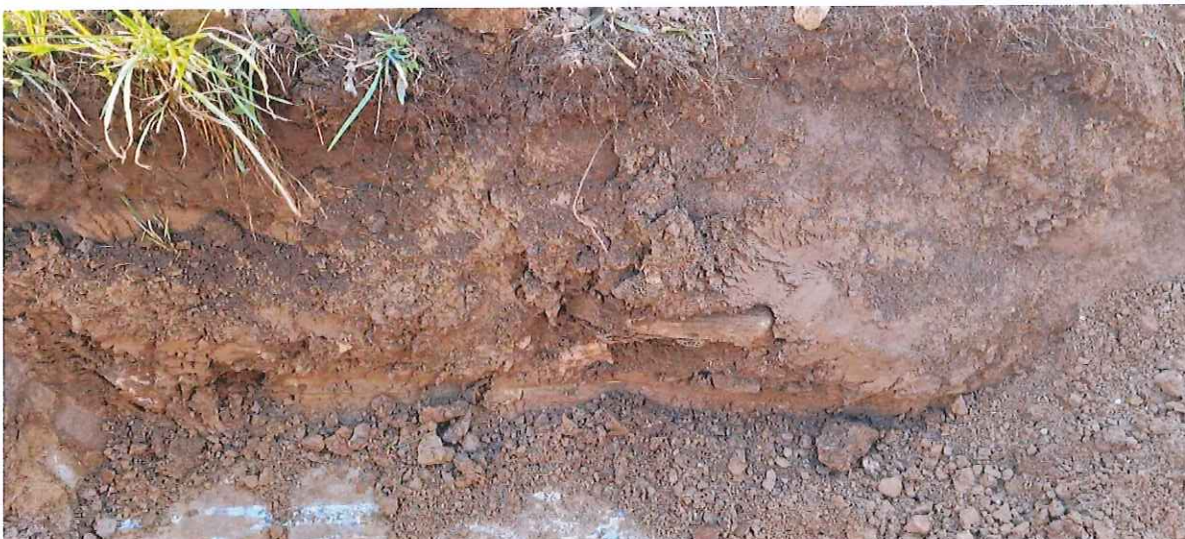
Picture 6: TH-03 - Side view showing soil profile.

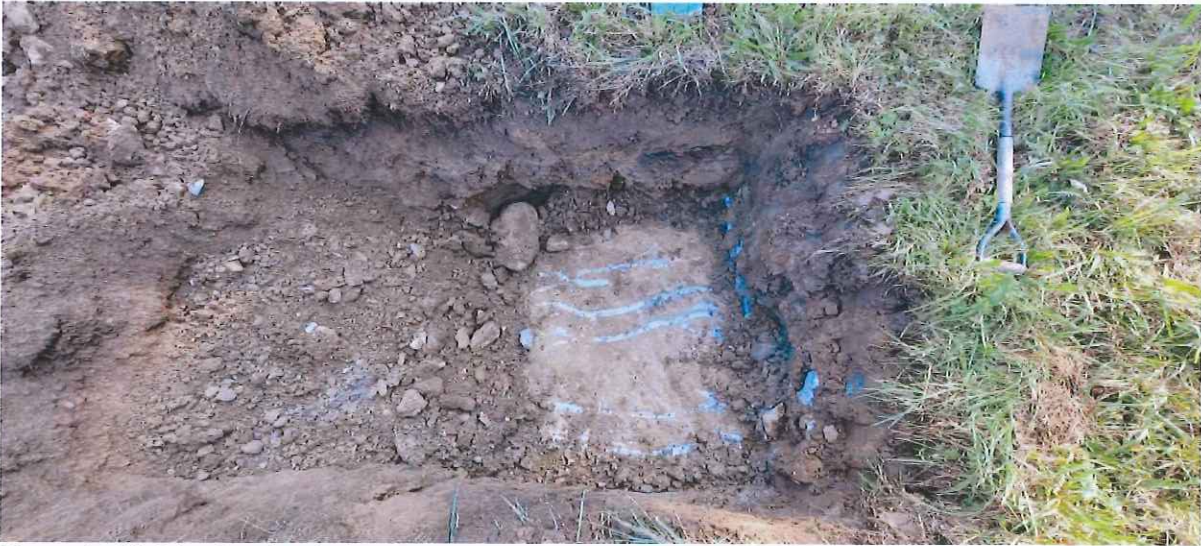
Picture 7: TH-04 – Overhead view.

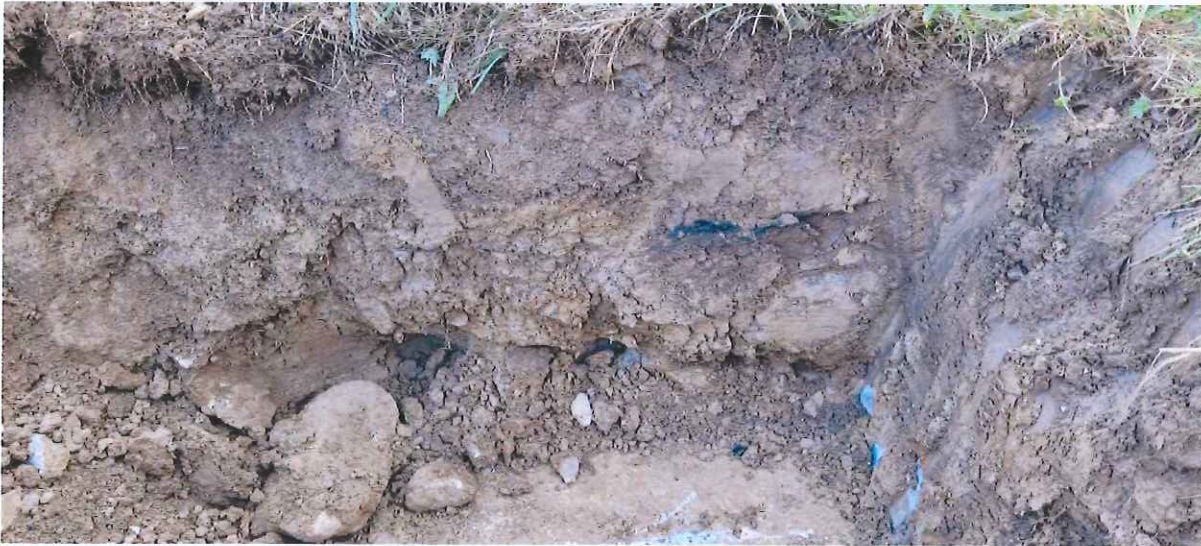
Picture 8: TH-04 - Side view showing soil profile.

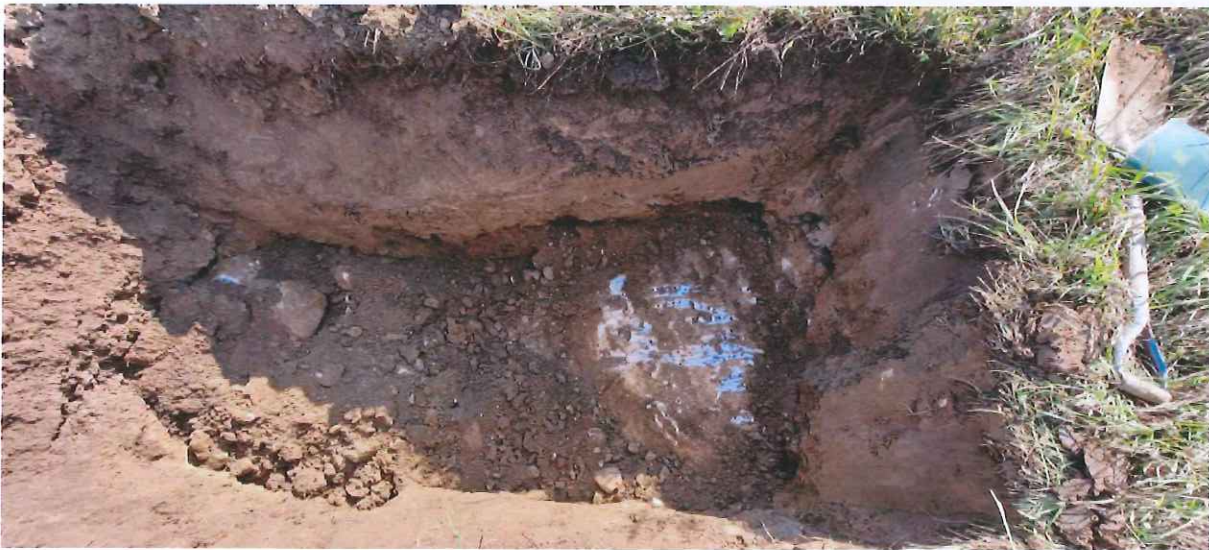
4. In addition to the above, TH05 intercepted a stony clay rich loam layer below the clay loam with higher amounts of gravel and cobbles reaching up to 35%.

Picture 9: TH-05 – Overhead view.

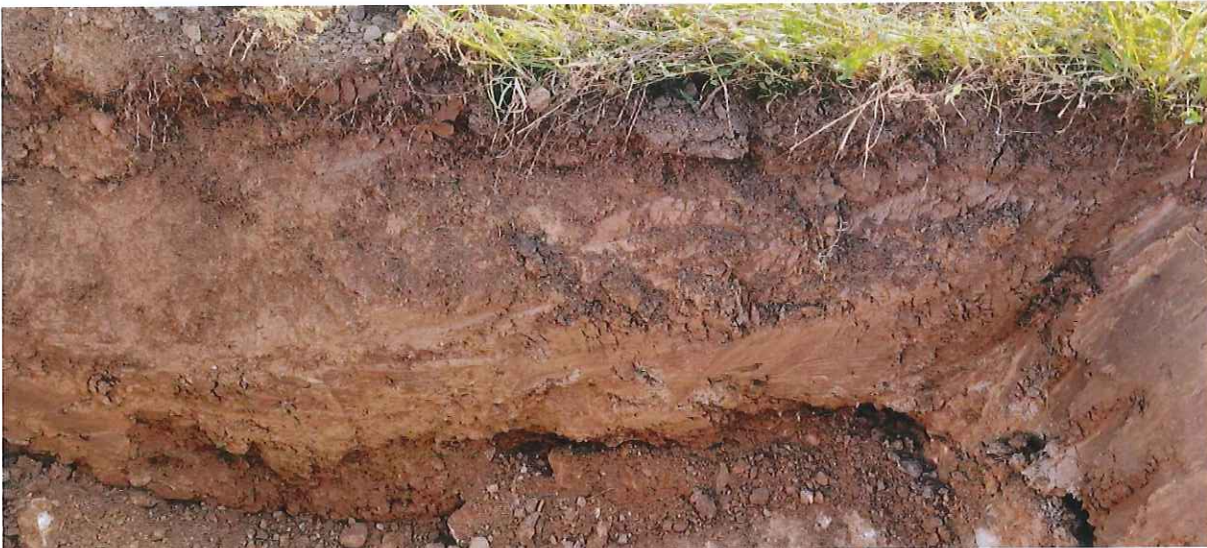
Picture 10: TH-05 - Side view showing soil profile.

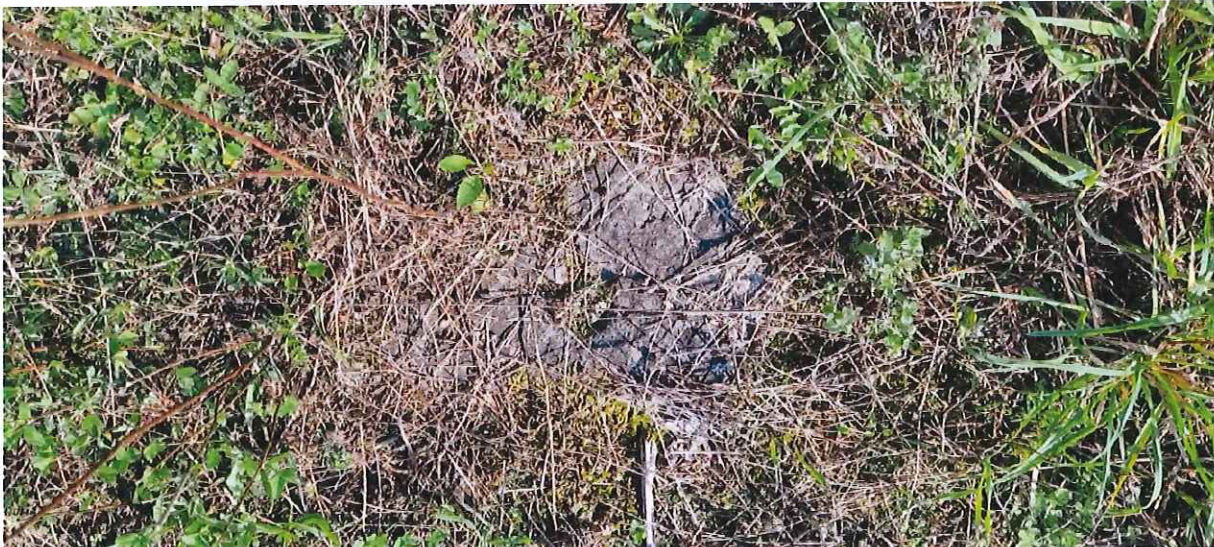
Picture 11: One of the bedrock outcrops visible at surface.
