## Summary Action Report

Structure ID: K-0009

Structure Name: Big Bay Culvert

Inspection Date: June 3, 2024

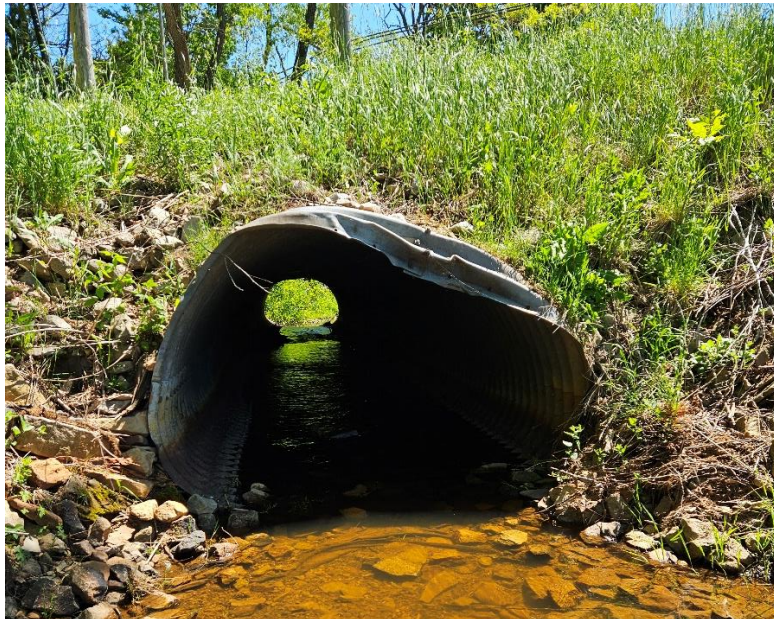
The structure appears to be in overall critical condition with large perforations and evidence of active overstressing of the culvert barrel walls. There are two large perforations noted at the north and south walls of the culvert. The north perforation measures 4.0m x 0.3m, which has caused the north wall of the barrel to settle and slip below the invert. Bolt hole cracking and crimping of the barrel corrugations was also noted along the south wall. Due to the presents of these deficiencies, the structure appears to be exhibiting buckling / failure issues and urgent replacement of the culvert (within 1 year) is recommended.
