Summary Action Report

Structure ID: K-0009

Structure Name: Big Bay Sideroad Culvert

Inspection Date: June 3, 2024

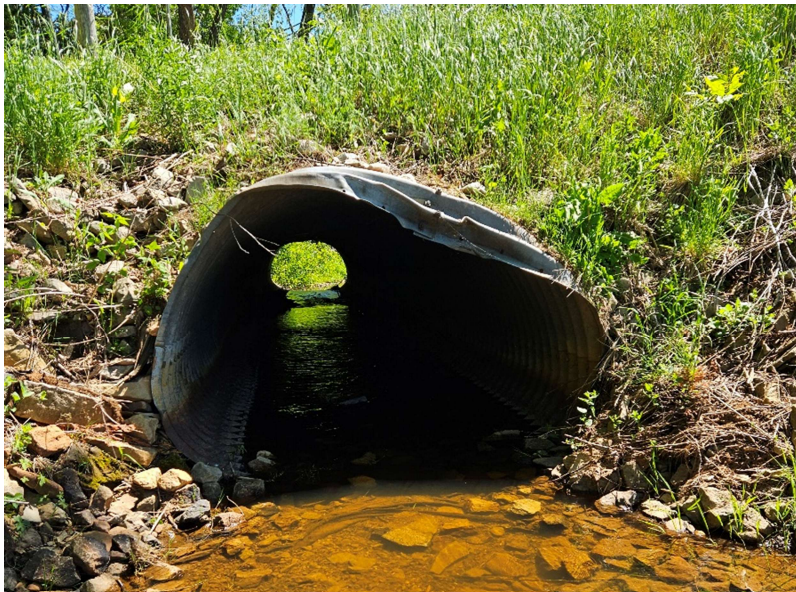
The structure appears to be in overall critical condition with large perforations and evidence of active overstressing of the culvert barrel walls. There are two large perforations noted at the north and south walls of the culvert. The north perforation measures 4.0m x 0.3m, which has caused the north wall of the barrel to settle and slip below the invert. Bolt hole cracking and crimping of the barrel corrugations was also noted along the south wall. Due to the presents of these deficiencies, the structure appears to be exhibiting buckling / failure issues and urgent replacement of the culvert (within 1 year) is recommended.
